## Ballston Lake Overview

## Ballston Lake is in Jeopardy

### **Danger Signs: Lake Studies Show Phosphorus Levels on the Rise**

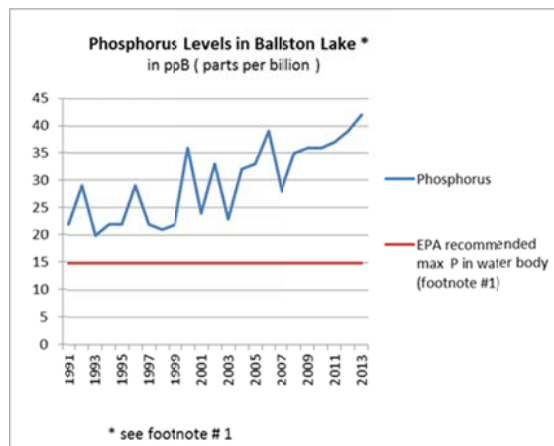
Long term tracking of lake water parameters by the Ballston Lake Improvement Association (BLIA) and the NYS Department of Environmental Conservation (DEC) shows that phosphorus levels are significantly increasing. From a base level of 22 ppB (parts per billion) in 1990, the level remained relatively stable for many years, but began steadily rising over the past decade and has soared to 42 ppB in 2013. The Lake is overloaded and cannot continue to absorb the current levels of phosphorus.

*Footnote # 1: All years except 2000 consist of average of 8 data points, 2000 is single point. Testing done under the CSLAP ( Citizens Statewide Lake Assessment Program ) which is managed by DEC and the New York State Association of Lakes. Please see NYS DEC website for further details. Tests were analyzed by DEC. EPA threshold for Lakes of 14.75 ug/L from EPA summary table guidelines for lakes in ecoregion VII*
